Investigation No. 880263 Fiscal Year 2012 DFW Regional Office

Sampling Points Table and Aerial Photograph

Exide Technologies-Frisco

INVESTIGATION DATES: 06/28/2011-06/29/2011

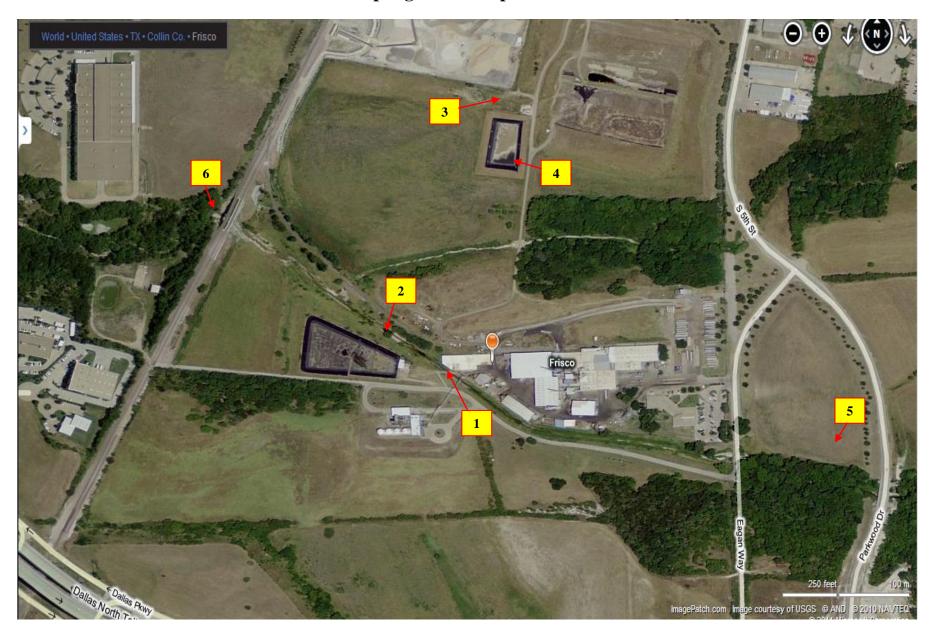
Exide Sampling Points Map - June 2011

Map ID No.	Project No.	Liquid (L); Soil/Sediment (S) Grab (G) Composite (C)	Sample Details	Constituents of Concern
1	421667-01	S, G	-Stewart Creek embankment south of the barrier wall and near the Battery Receiving and Storage Area.	-Total Lead = 940 mg/kg -TCLP Lead = Below Detection -Total Cadmium = 46.5 mg/kg -TCLP Cadmium = Below Detection *Total Zinc = 615 mg/kg (no Class 1 or Hazardous Characteristic standard for Zinc)
2	421667-02	L, G	- Stewart Creek near Stormwater Outfall-001	-None *trace levels of barium @ 0.0670 mg/kg
3	421667-03	S, G	-North on-site air monitor	-Total Lead = 196 mg/kg -TCLP Lead = Below Detection
4	421667-04	L, G	-Solar Evaporation Pond	-None
5	421667-05	S, G	-Area east of the facility (background)	-None
6	421667-06	S, G	-Off-site battery chips	-Total Lead = 139 mg/kg -TCLP Lead = 1.79 mg/L
